BUYING A TRIUMPH RAZOREDGE SALOON? A SHORT GUIDE TO THINGS TO LOOK OUT FOR

By Bob Hobbs

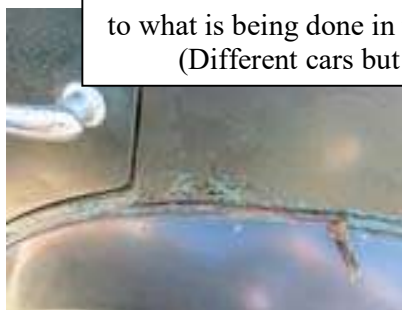
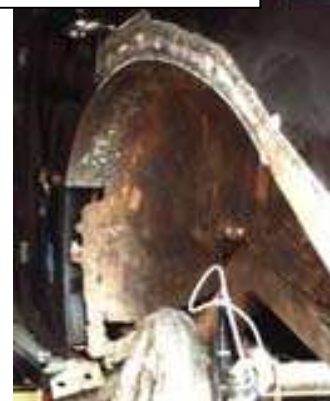
1. Above the rear wheel arch where the rear wing attaches. Look very carefully at the whole length of the arch from the bottom of the door opening around the quarter panel to the rearmost point. Any unevenness in the paint surface here is indicative of corrosion in the metal and almost certainly rot in the ash frame behind. There are a number of cars where the dreaded filler has been applied to try to hide the problem. This is only ever going to be a cosmetic short term fix and to resolve the issue requires wing removal, followed by woodwork and metalwork repairs. This is all straightforward to do but can be quite daunting.

What is seen in the left hand picture can lead to what is being done in the right hand image. (Different cars but same problem)

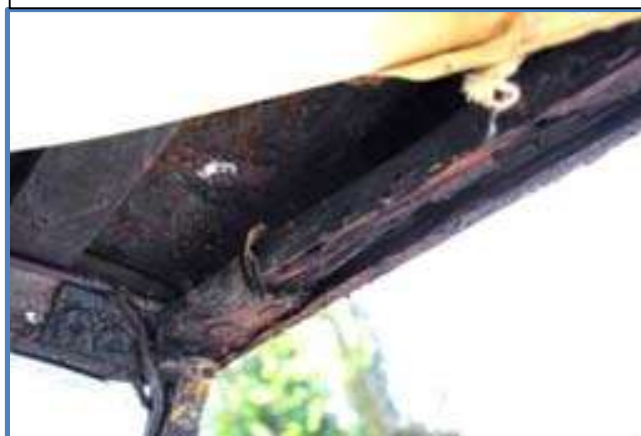
5. Higher up on the car now. Look carefully at the gutters. These are fixed to the roof by a number of screws that pass into the supporting wooden frame. These screws are hidden by the rubber door seals. Water leaks in this area are serious. If not attended to correctly, the metal of the gutter and the adjacent roof will be severely damaged and the wood frame will have rotted away. The water will make its way towards the front of the car where it will drain down the “A” pillar. Underneath the chrome capping of the windscreen surround are the mild steel angle sections that support the front of the roof. These

Leaking gutters leading to rotten wood and metal

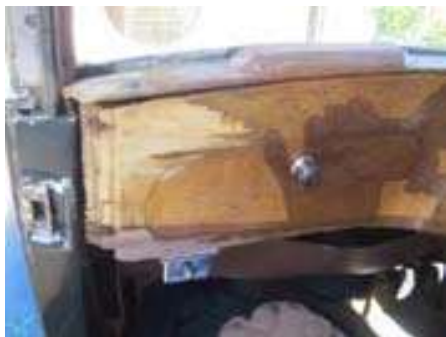
An extreme example of decay!

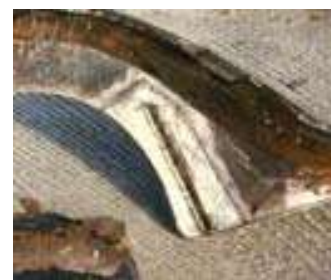
The rear wings have a problem with their design that is out of sight but this is not a situation that remains for

ever. In the broad area just behind the wheel there is a support panel that sits behind the wheel. This is fixed to the inner wing inboard and to a flange on the wing at its outboard end. The flange on the wing is where the trouble begins. It is welded to the wing at its front end from where it proceeds rearwards at a shallow angle to the wing's outer surface. This is one of the car industry's best ever mud traps. More metalwork is needed to resolve the problem. With some lateral thinking it is possible to eliminate the mud trap altogether as shown in the 3rd picture above.

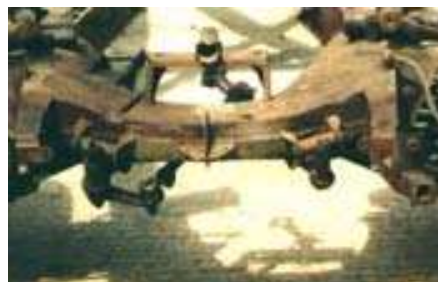
8. The underneath of the front cross member and the bottom zones of the front and rear faces. These corrode badly and in some instances have cracks that affect structural integrity. Look very carefully at the webs that support the steering idlers. Where these are welded to the front of the cross member is under high stress with the steering loads on the idlers. Cracks here are dangerous and can lead to total failure of the steering geometry and thus loss of control of the car in the event of total failure. Repairs are not too difficult with reasonable access to all the sections that might need repair.

TDC front cross member showing mounts for steering

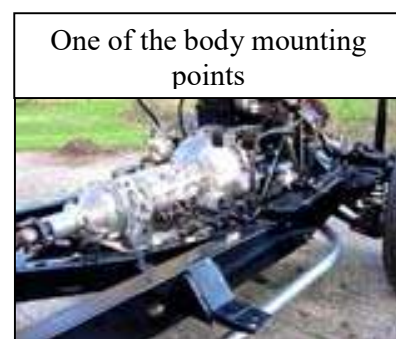
10. Along each side, further back, there are several mounting points for the sub-chassis. These tended to accumulate mud and thus can often need attention to the consequent corrosion. Access is more difficult if one is attempting repairs with the wings and body still mounted on the chassis. As a result, though the repair is relatively easy to do, it can require extensive work.

One of the body mounting points
