Service Instruction Manual

SERIES I AND II
and
TRIUMPH "RENOWN" MODELS

COOLING SYSTEM SECTION C

THE STANDARD MOTOR COMPANY LTD., COVENTRY

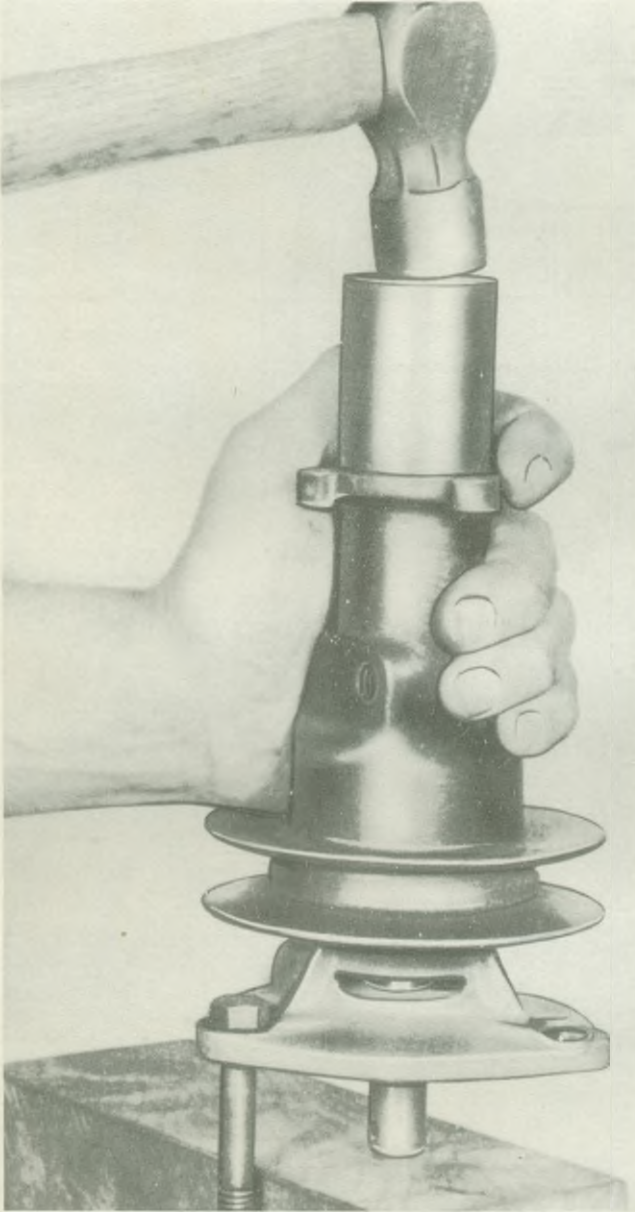
Fig. 5. Fitting fan extension bracket to bearing housing
