Service Instruction Manual

SERIES I AND II
and
TRIUMPH "RENOWN" MODELS

FRONT SUSPENSION AND STEERING SECTION G

THE STANDARD MOTOR COMPANY LTD., COVENTRY

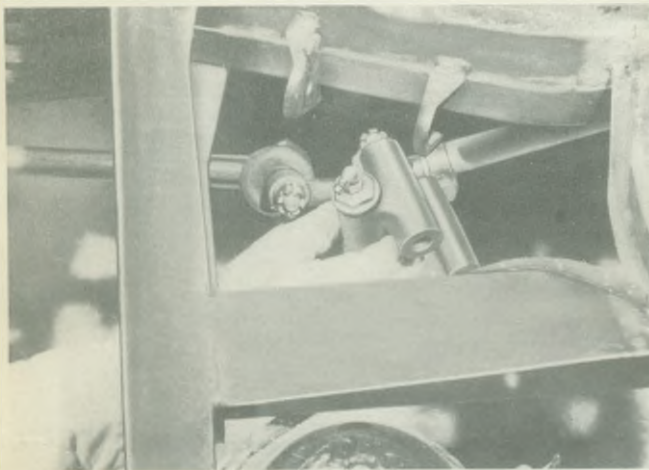
Fig. 26. Adjusting positing of auxiliary bracket to align centre tie rod with drop arm

chassis cross member. The method for this adjustment is to withdraw the two auxiliary bracket bolts (which should be still loose) and to rotate the bracket as shown in Fig. 26 as, or where, necessary. Three turns out should usually provide the correct setting and under no circumstances should more than five be required.
