ENGINE—Overhauls and Adjustments

FRAM OIL AND ENGINE CLEANER— TYPE FHMS.800 (Eng. No. V312E— V89332E. Less V89283E—V89294E)

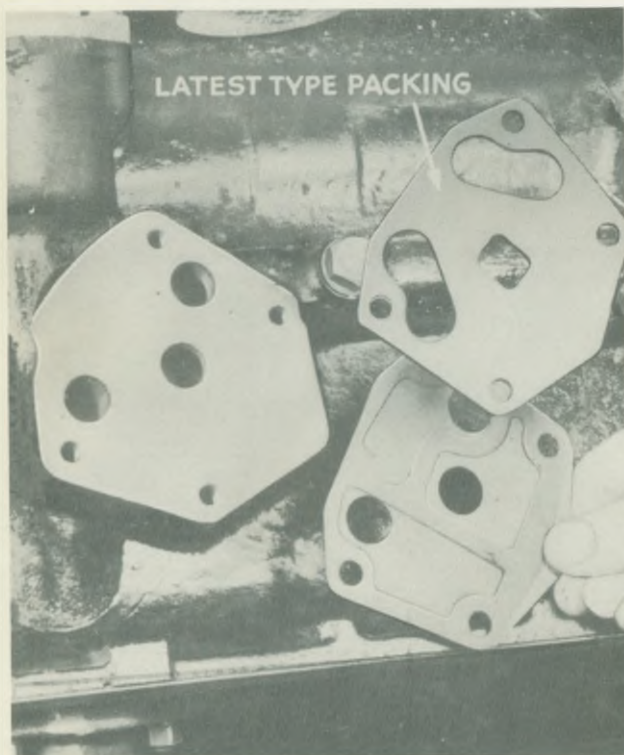
It is important when removing the filter bracket and packing washer for any reason to ensure that the packing is refitted so that oil holes are in correct relation to those in cylinder block (see Fig. 36). With the latest type of packing shown the correct assembly is foolproof. (See also Page 50.)

Fig. 36. Correct fitting position for oil cleaner packing washer. The latest type of packing the fitting of which is fool-proof, is inset

HOLES IN PACKING WITH THOSE IN CYLINDER BLOCK (SEE FIG. 36). WITH LATER PACKINGS CORRECT ASSEMBLY IS AUTOMATIC.

If at any time the entire filter unit is removed from the crankcase, take great care to fit the joint washer correctly, otherwise damage will be caused when next the engine is started, through the "blanking-off" of the oil passages. It is advisable to fit the washer to the crankcase and ensure that the holes in the washer match those in the crankcase before fitting the filter unit.

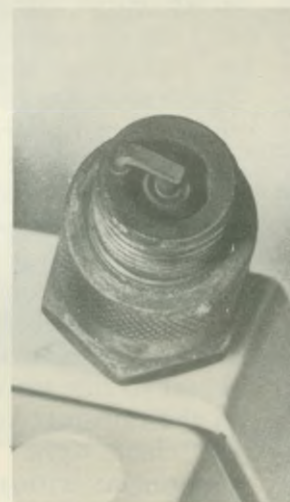
Fig. 44

Fig. 45

2. **Look for signs of oil fouling, indicated by wet, shiny, black deposit on the insulator.** Oil pumping is caused by worn cylinders and pistons or gummed-up rings. On the suction stroke of the piston, oil vapour from the crankcase is forced up past the worn rings, where it fouls the plugs and causes sticking valves, with resultant waste of petrol. On the compression stroke, the mixture of oil and petrol vapour is forced past the rings into the crankcase again, contaminating the oil and turning it black with carbon. Carbon deposits in the combustion chamber are formed from burning oil vapour and cause "pinking."

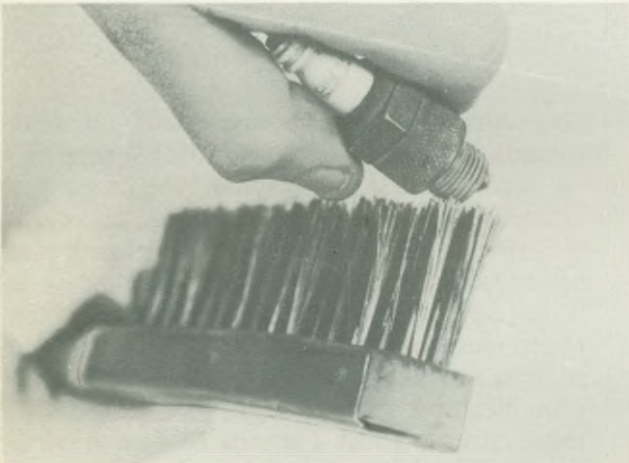
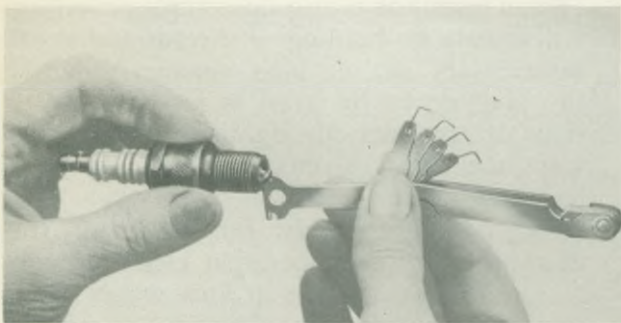
However, the strains of intense heat, pressure mechanical shock, electrical and chemical action, during miles of service, wreak such havoc on the electrodes that molecular construction is affected. Plugs reach a worn-out condition and resetting can serve a good purpose only for a time. When gaps are burned badly, it is indicative the plug is worn to such an extent that further use is unwarranted and wasteful. When resetting, bend the Side Wire only, never bend centre electrode as this may split the insulator tip.

Fig. 49

Fig. 50
